# Evaluation of drainage enhancement for vegetation recovery in salt marshes in New England using public aerial imagery

**Grant McKown\*, David Burdick, Gregg Moore,  
Jenny Gibson, and Wenley Ferguson**  
**\*Jackson Estuarine Lab, University of New  
Hampshire**

## Evaluation of Drainage Enhancement for Vegetation Recovery in New England Salt Marshes Using Public Domain, High-Resolution Aerial Imagery

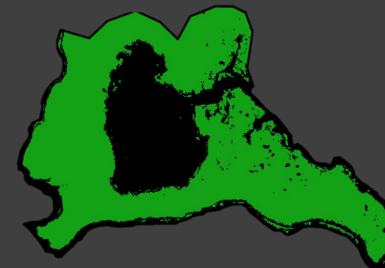
2021

## UVVR Calculation

$$UVVR = \frac{\sum \text{Unvegetated Pixels}}{\sum \text{Vegetated Pixels}}$$

$$\frac{14298}{28717} = 0.50$$

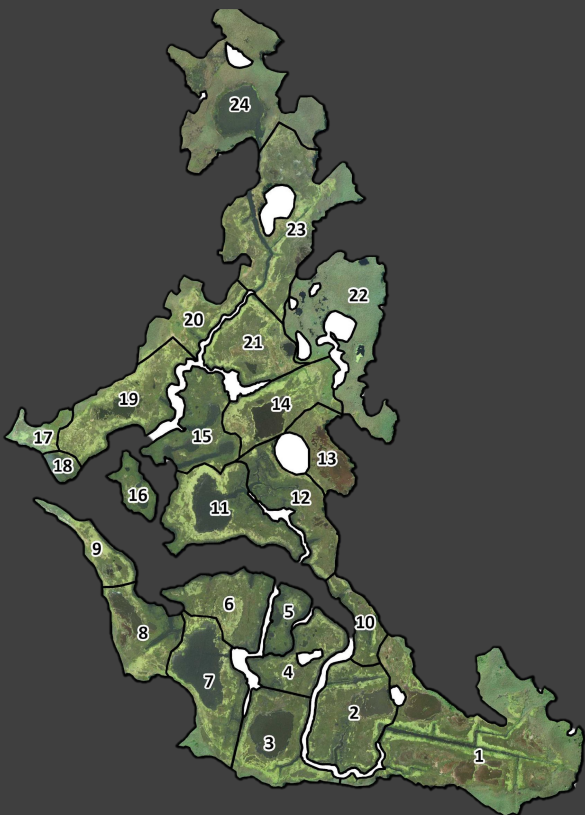
# Classified Sub-tidesheds

| Treatment | Tidesheds | Acreage |
| Reference | 48 | 277 |
| Runnel | 68 | 324 |
| No Action | 72 | 378 |
| Miscellaneous | 89 | 747 |
| Retained in Analysis | 188 | 981 |

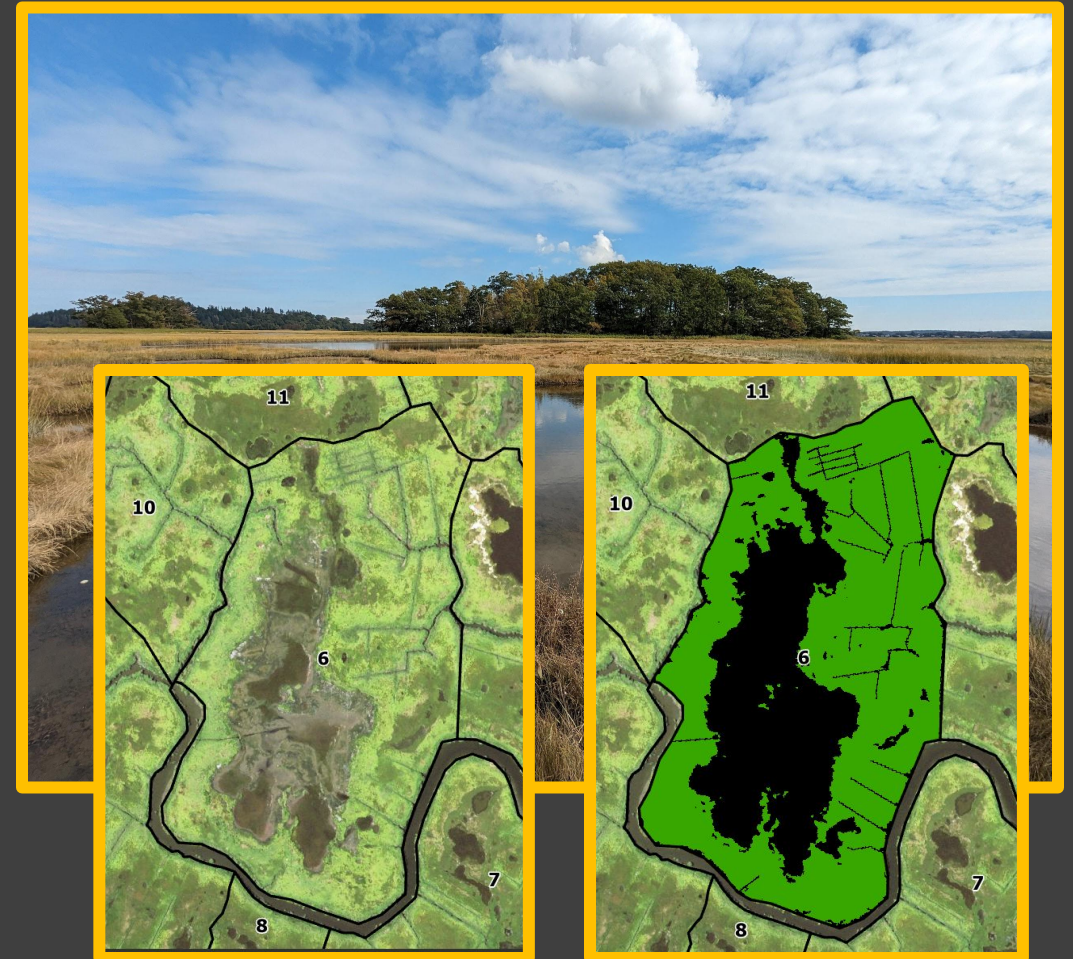
**Degraded Pool Condition**  
**UVVR > 0.15**
