CASTLE NECK RIVER RESTORATION MONITORING Pre-Restoration Baseline Findings (2024-2025)

IPSWICH RIVER
WATERSHED ASSOCIATION

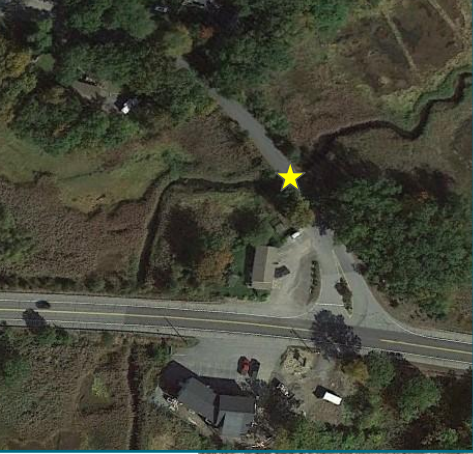
Project Site

Old Essex Road culvert is **undersized** and **restricts tidal flow**
Roadway **fragments marsh habitat**

- Pooling
- Erosion
- Delayed tidal flux
- Impaired marsh health
- Limited stream and habitat connectivity

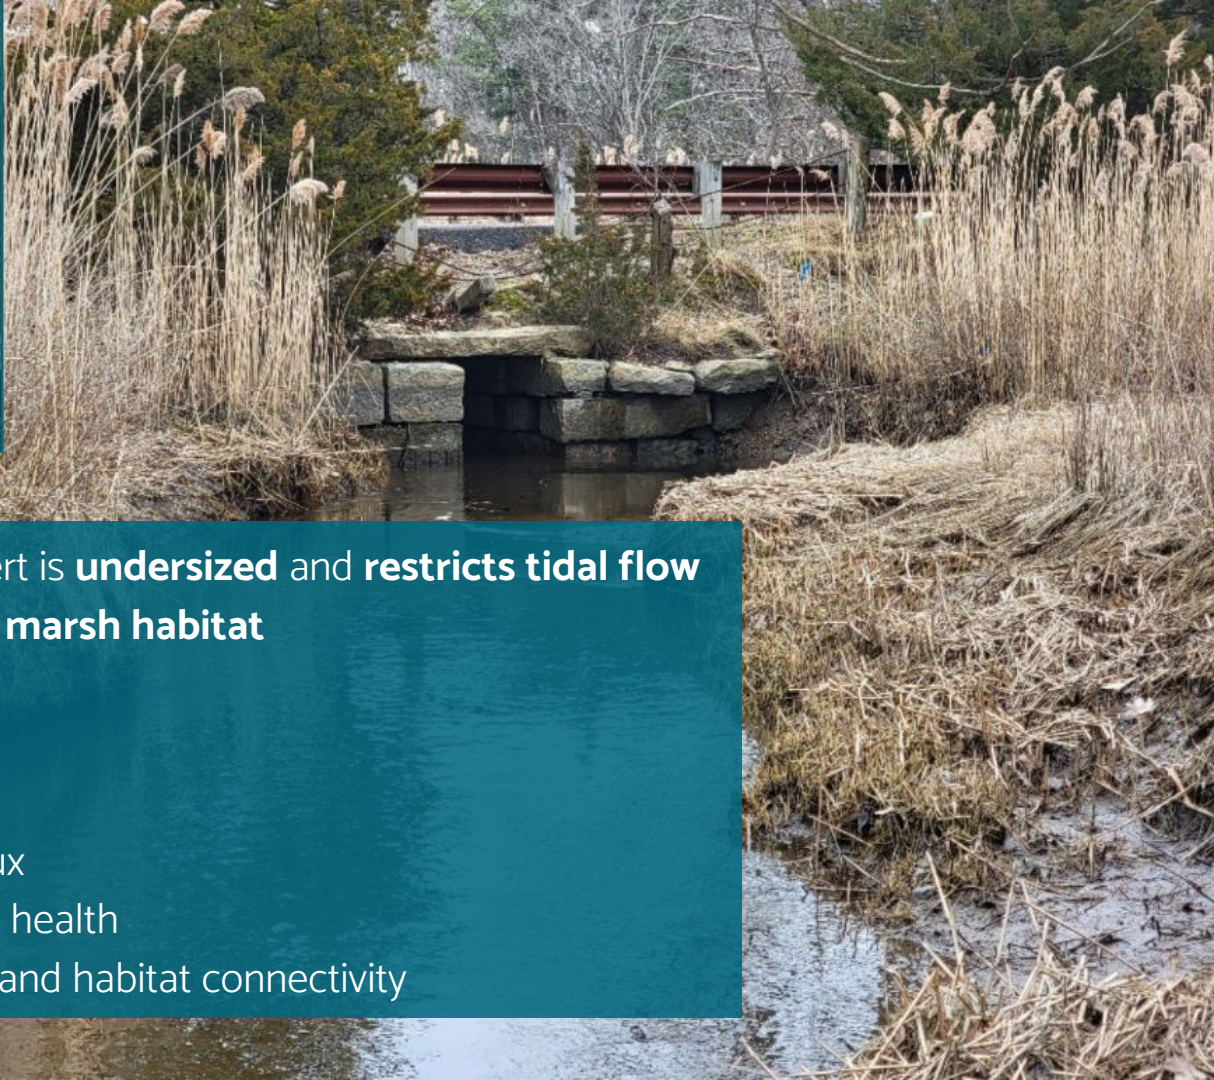
Impacts:

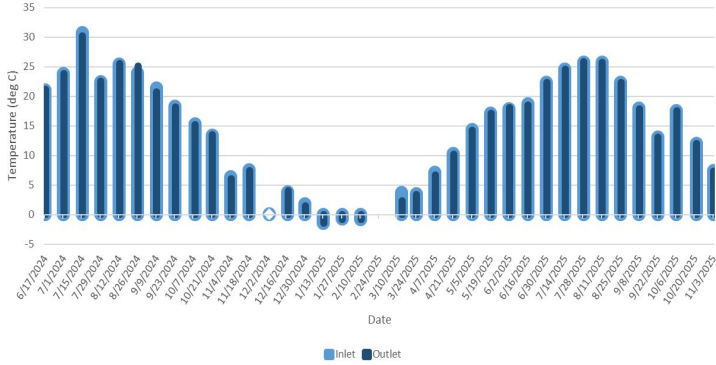
Temperature over Time

Parameters: Temperature, Dissolved Oxygen, Conductivity & Salinity

Key Finding: No measurable difference between inlet and outlet

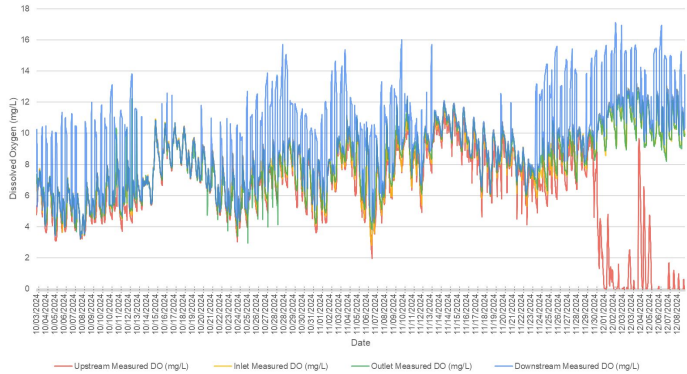
2024 Dissolved Oxygen Data in Castle Neck River

Parameters: Temperature, Dissolved Oxygen, Conductivity & Salinity
Purpose: Capture seasonal, tidal, & spatial patterns
Key Findings: Seasonal signal – Temperature & Dissolved Oxygen
Tidal signal – Dissolved Oxygen, Conductivity, & Salinity
Spatial signal – absent

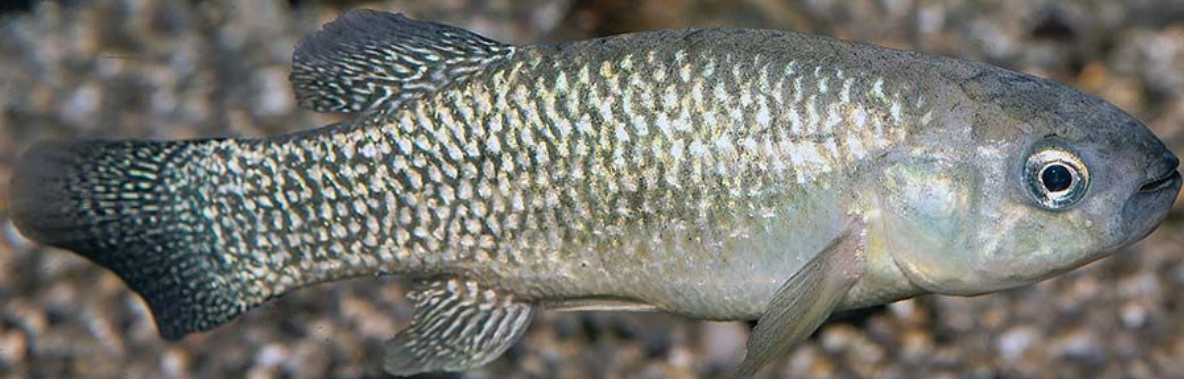
Set Up:

Deploy Fyke net for 24 hours

Catch dominated by mummichogs

Near total absence of other species

May indicate poor water quality/lack of suitable habitat
